Kildare Co. Council

Dara Park

**Preliminary Report on Flooding which occurred on
Wednesday 22nd November 2017**

23rd November 2017

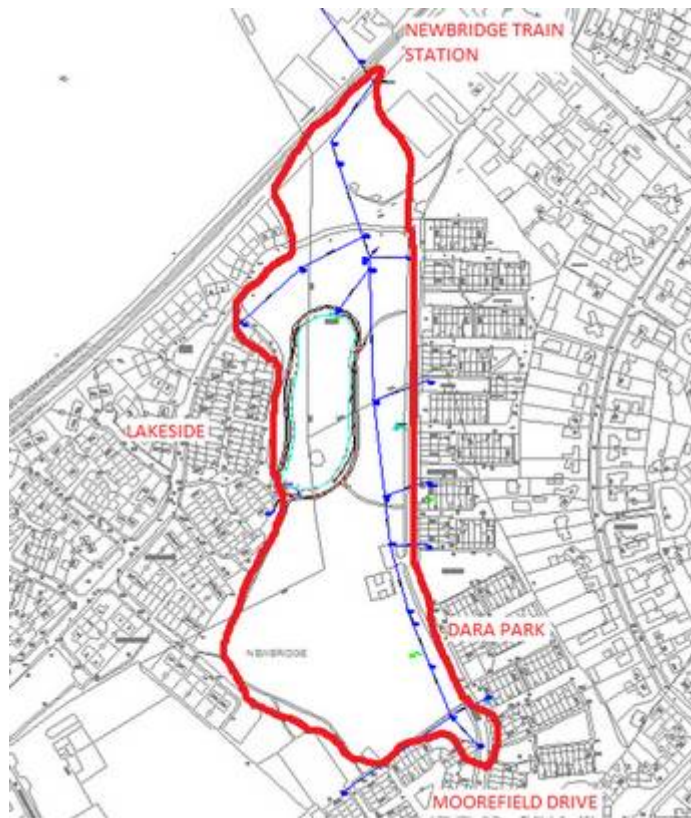
Fig 1: Study Area

3.9 With reference to Fig. 1, in one area of Dara Park there was a separate and unrelated drainage issue where a foul sewer adjacent to houses became surcharged and overtopped the manhole resulting in a sewage discharge and localised flooding. This manhole is part of a foul drainage system that is not connected to any of the piped network associated with the Dara Park Drainage Improvement Works. We understand that this drainage problem relates to poor capacity and falls within the foul network combined with surface water surcharge from overflows during severe rainfall events, as occurred yesterday.

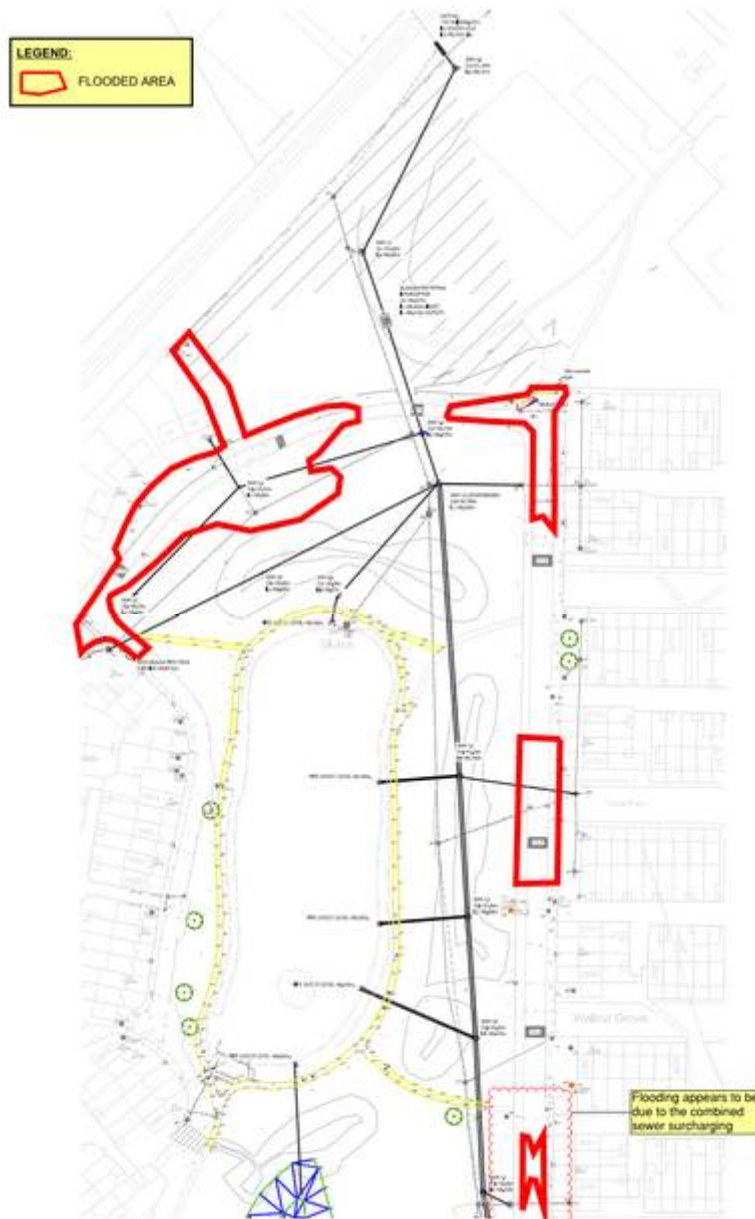
3.2 Flooding of some road areas occurred in Dara Park from this storm Event. Donnachadh O'Brien & Associates attended site on the morning of the 22nd November, and the images below illustrate the flooding of low lying roads experienced.

Fig 2: Extent of Flooding Observed

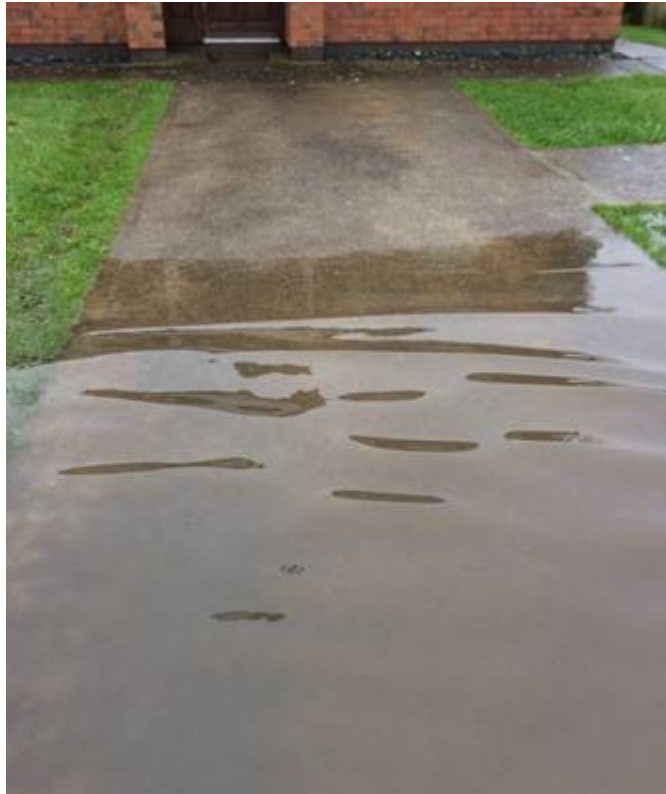
3.3 From our inspections, in areas where flooding of roads was evident, no houses were flooded and the worst affected area were the bungalow houses in Lakeview Crescent where some of the driveways had lying water evident for 50% of the driveway. This area is the lowest part of the site and has always experience the worst historic flooding.

Figure 3 : Worst Affected Property from Surface Water Flooding – Lakeside Crescent

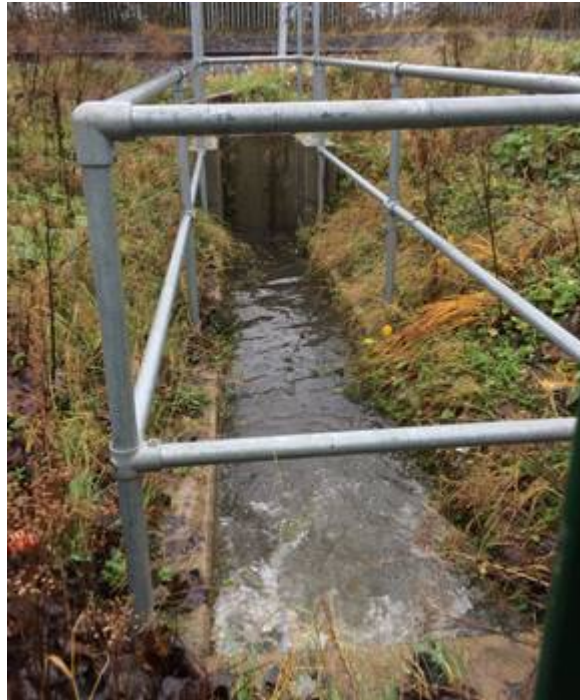
3.4 Following inspection, it became apparent that the reason for the surcharging of the surface water network and flooding was a partially blocked trash screen in the adjacent Irish Rail Property at the entrance to the culvert. This was blocked with debris and was preventing the full flow of water from entering the culvert (see figure 4 above showing the water level above the trash screen). This image was a taken at the time of maximum surcharge at approx. 12pm.

The nature of the debris included, leaf's and twigs and other vegetative matter but also plastic, some general rubbish including a disused fire extinguisher that appears to have been disposed of in the culvert. Had this large object not been trapped by the trash screen, it is likely to have caused a

severe blockage of the culvert below the railway like in an inaccessible area and therefore the trash screen was performing its function effectively.

Figure 4 : raised water level at culvert entrance due to debris blocking the trash screen at the entrance to the culvert located in Irish Rail Property

3.5 Trash screens, by their very nature require regular maintenance to remove caught debris and to ensure a through passage of the design flows. In this case the flow was restricted by debris to approximately 25% of the culvert capacity. This was verified by Kildare County Council who opened up manhole chambers on the downstream side of the Railway Culvert.

4.2 The flooding was caused by debris blockages at a trash screen located in the immediately adjacent Irish Rail Property to the north of the site. This trash screen protected a culvert traversing below the railway line where the entire 23-hectare urban catchment discharges. Dara Park is located in the lower reaches of this catchment. This culvert was reduced to approximately 25% of its normal capacity.

4.7 It is imperative that an ongoing maintenance regime is put in place in relation to the installed Surface Water Improvement Scheme to mitigate against any similar occurrences in the future.

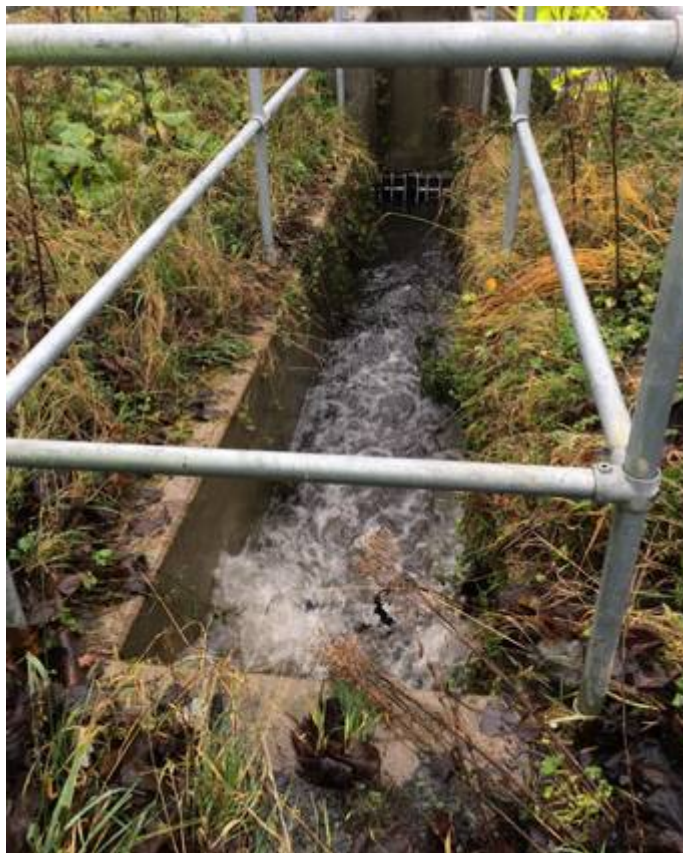
3.8 Kildare County Council acted swiftly and immediately and arranged access for maintenance staff to the Irish Rail property and removed debris from the trash screen to restore design flow through the railway culvert. Immediately, by approximately 1pm there was a significant reduction in the water level by 500mm to 600mm at the outfall, as figure 5 below illustrates, when compared to figure 4. (The trash screen is now clearly visible in figure 5)

Figure 5 : reduced water level at culvert by approx. 500mm following removal of blockage to the trash screen

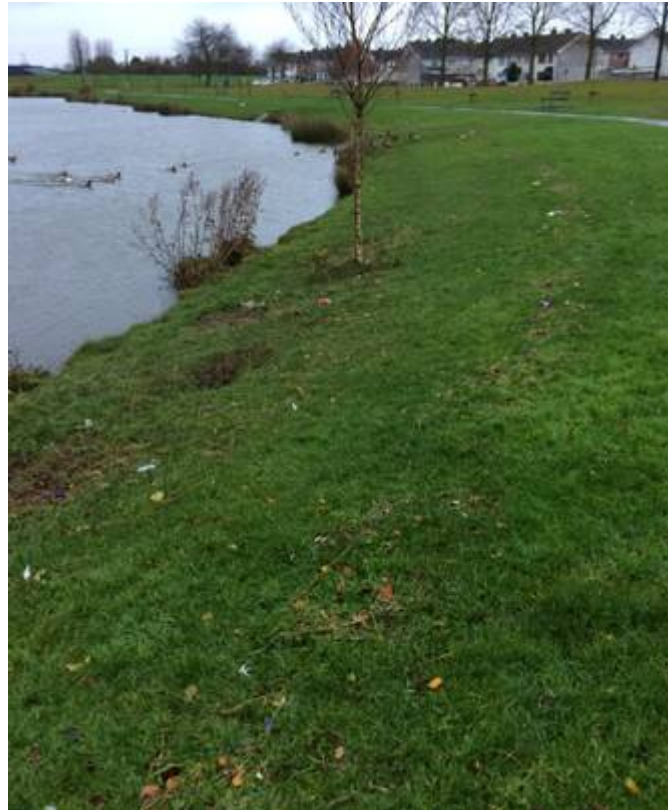
3.9 Further inspection at approximately 5pm showed that the water levels had reduced and there was a very significant reduction in the flooding to the roads within Dara Park and Lakeside crescent. On further inspection this morning (23rd November 2017) at 9am, the lake had returned to normal water levels and it was apparent that the attenuated water volumes had been discharged, with the culvert outfall operating in a normal manner.

Figure 5 : Normal water level restored in the lake at 9am on Thursday 23rd November. (see the high water mark on the bank)
